May 18, 2012
 Kleinfelder Project No. 124637

**Subject: Concrete Core Photographs
 and Compressive Strength Testing Results
 I-80 Bridge and Tunnel Rehabilitation Scope B – Elko County
 Elko County, Nevada**

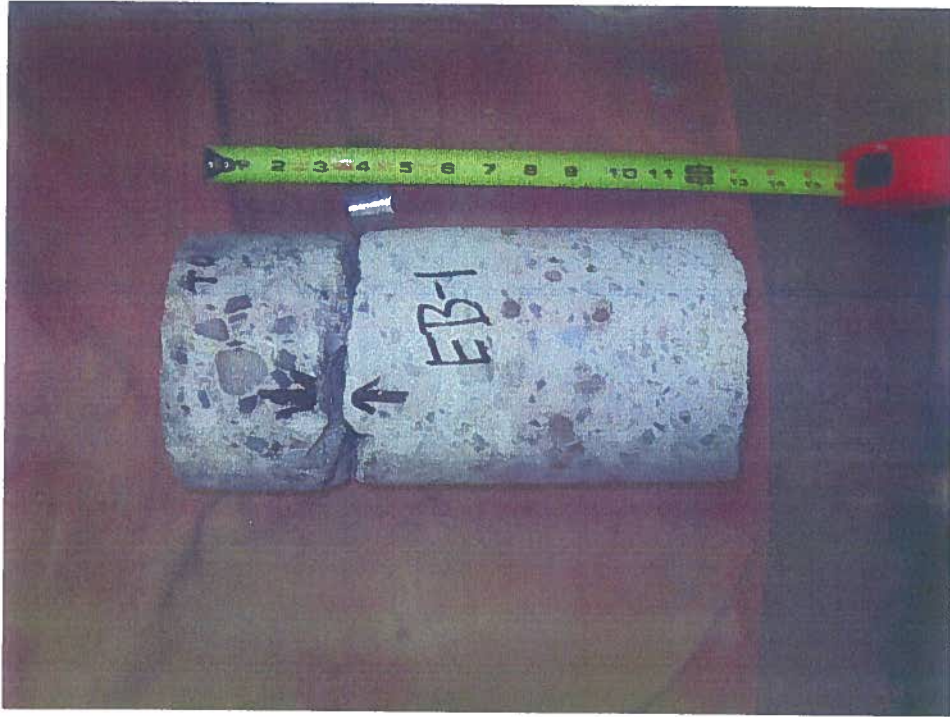
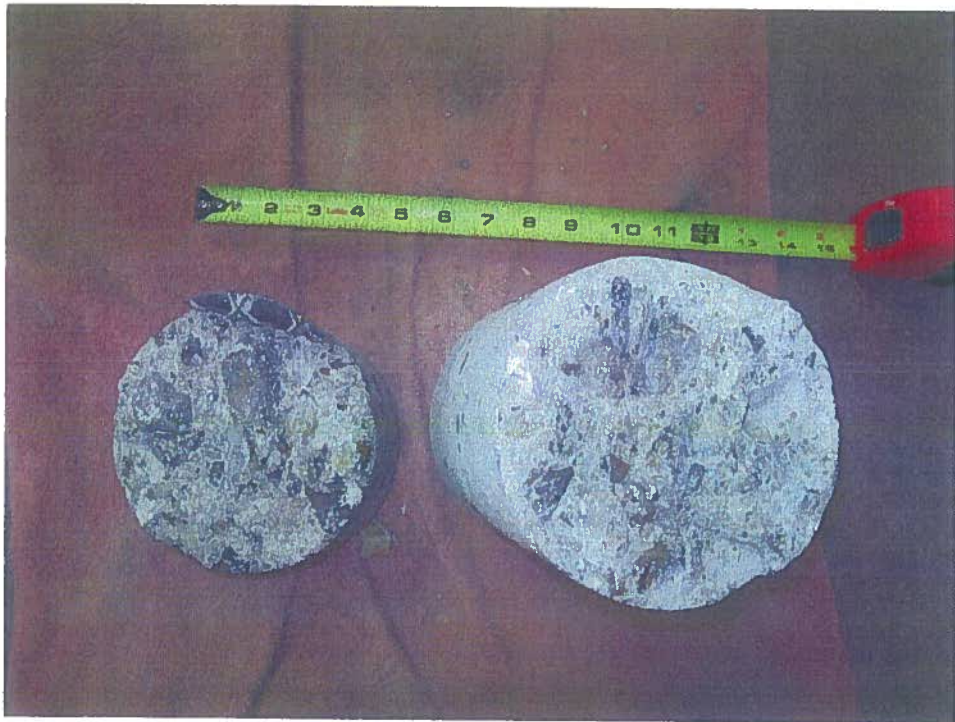
All cores were removed intact with the exception of cores EB-1 and EB-2. Core EB-1 was broken horizontally in one place, approximately 4 inches from the pavement surface as shown in Photos 1 and 2. This crack was also observed on the side of the core hole.

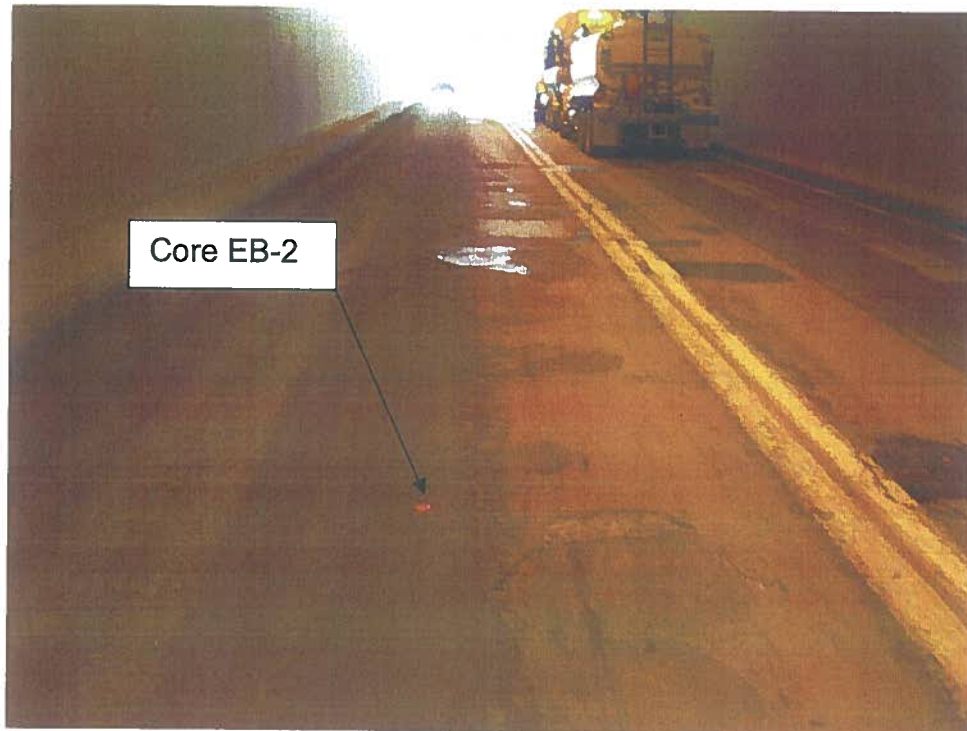
Photo 3

Core EB-2 was located in an area where the existing concrete contained several potholes, cracking, and patches as shown in Photos 3 and 4.

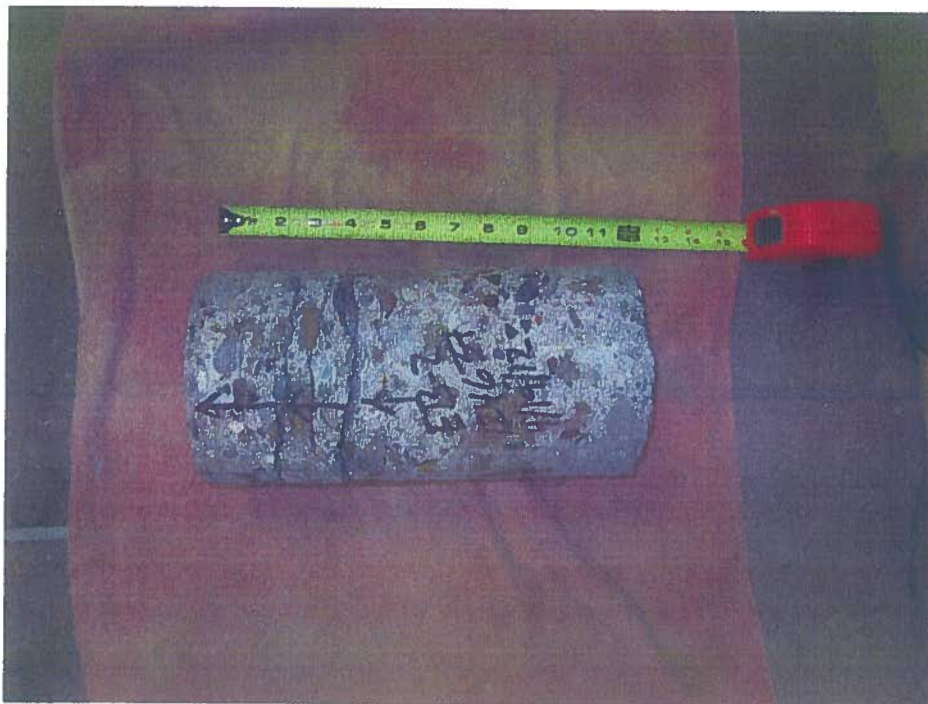
Photo 5

The removed core was broken horizontally in two places approximately 3 inches and 5 inches from the pavement surface as shown in Photo 5.

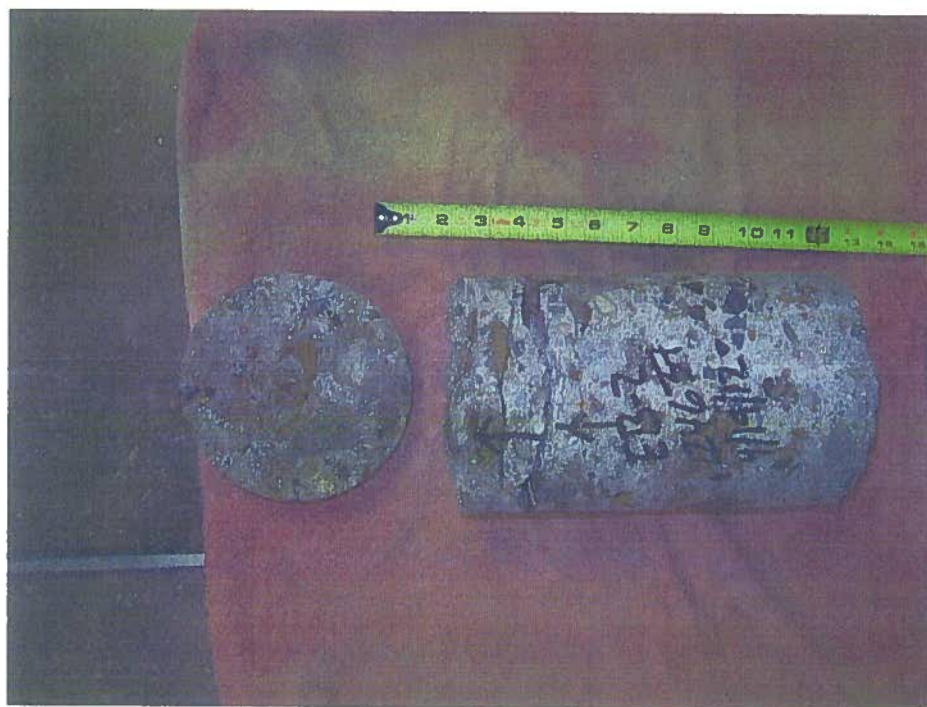
Photo 6

These cracks were also observed on the side of the core hole. The crack at a depth of approximately 3 inches is shown in Photo 6. The crack at a depth of approximately 5 inches was at the same depth as the rebar that ran horizontally through the center of the core.

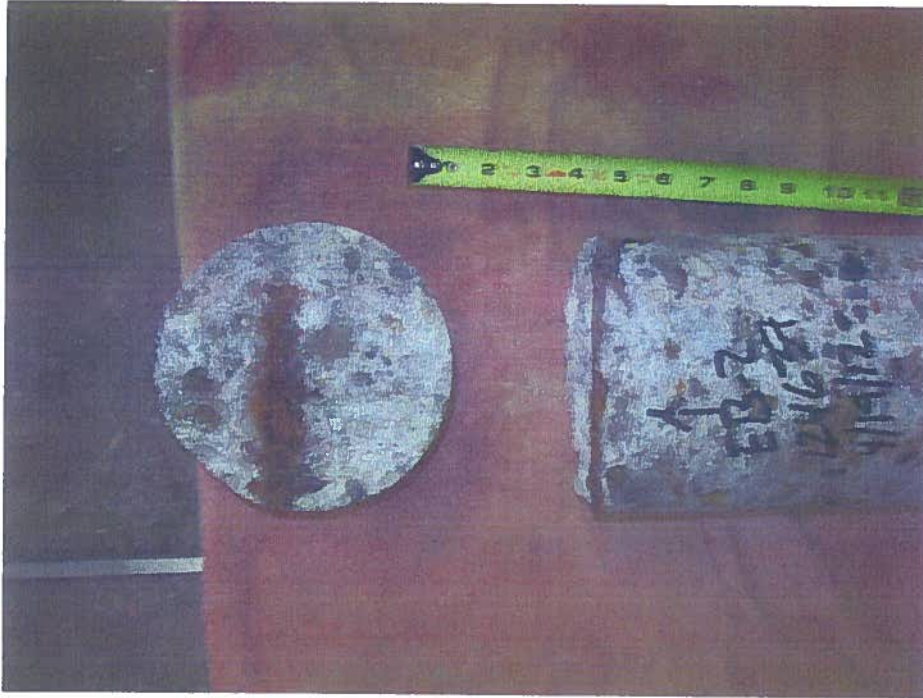
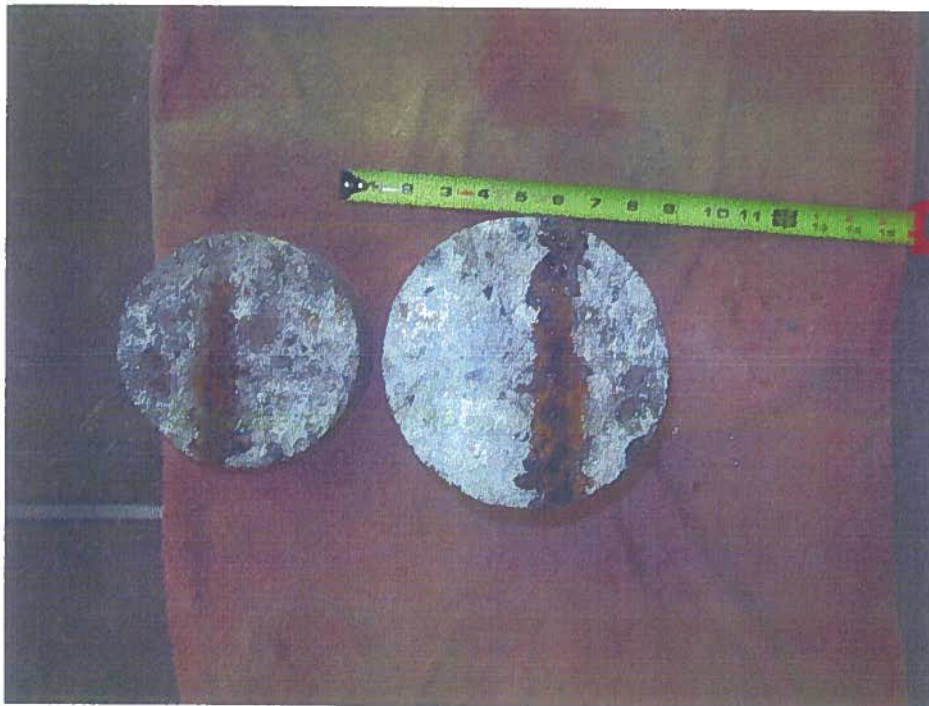
The rebar appeared to be undergoing corrosion with rust-color staining observed on the rebar and on the concrete as shown in Photos 7 and 8. Some light white staining indicating possible sulfate attack was present on the concrete as shown in photos 7 and 8. The rebar encountered in the cores with the exception of EB-2 did not show signs of corrosion or staining.
